Control Shaft Guide Pin

Column Shift

1946 Willys CJ-2A

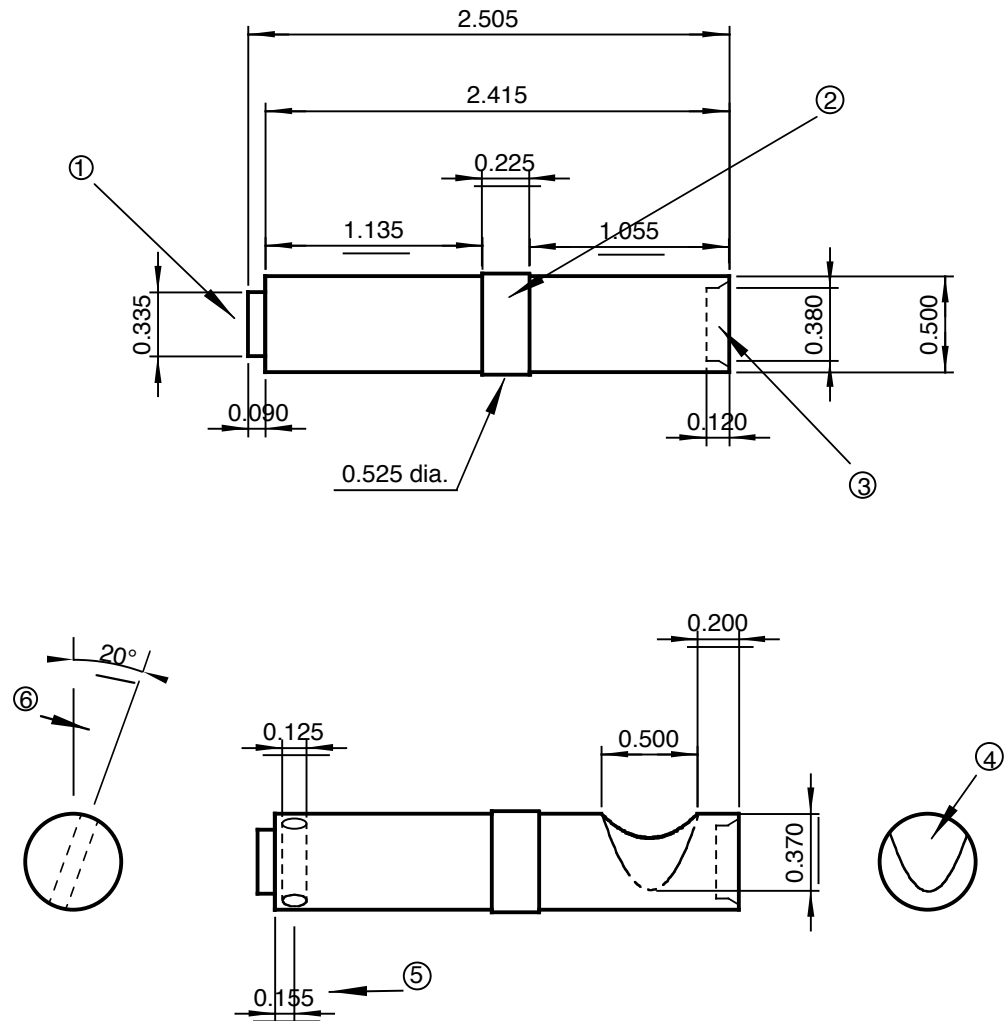
The part drawing is not exactly to scale. Dimensions are accurate as best I could measure considering 50+ years of wear.

1) The raised "nub" fits into a hole in the shift bracket on the steering column. It keeps the control shaft centered in the bracket.

2) This land keeps the control shaft from excess rocking on the pin. The position dimensions for this land around the pin are not critical. The original part had an irregular land shape. Anything approximating this should work.

3) Recess to fit bias spring

4) The shape of this bore is approximate. I have no way of precisely replicating the contour. It's location and depth are accurate.

5) The spring pin centerline distance is questionable. My original measured 0.150" on one side of the pin, and 0.160" on the other side. I split the difference to get 0.155"

6) The spring pin hole is not parallel to the shift lever bore axis. As close as I can measure, it's 20°.

WARNING: I am convinced this angle is NOT correct! It's possible that my guide pin, from which I took these measurements, is either:

- a) not an original Willys part, or
- b) was drilled incorrectly for spring pin alignment.
